Ador Germany	Frank Sauer
		Document type	Document status
		PDF	
		Title	DWG No.
		CROCO 102/107 CROCO 202/207	ADCRC10202
		Bsp. Fiat - Citroen - Peugeot	Rev. 0
			Date of issue 01.09.2022
			Sheet 1/1

https://ador-eu.de/ info@ador-eu.de		Document type	Document status
		Title CAYMAN 102	DWG No.
Rev.	Date of issue 01.12.2021	Sheet 1/1

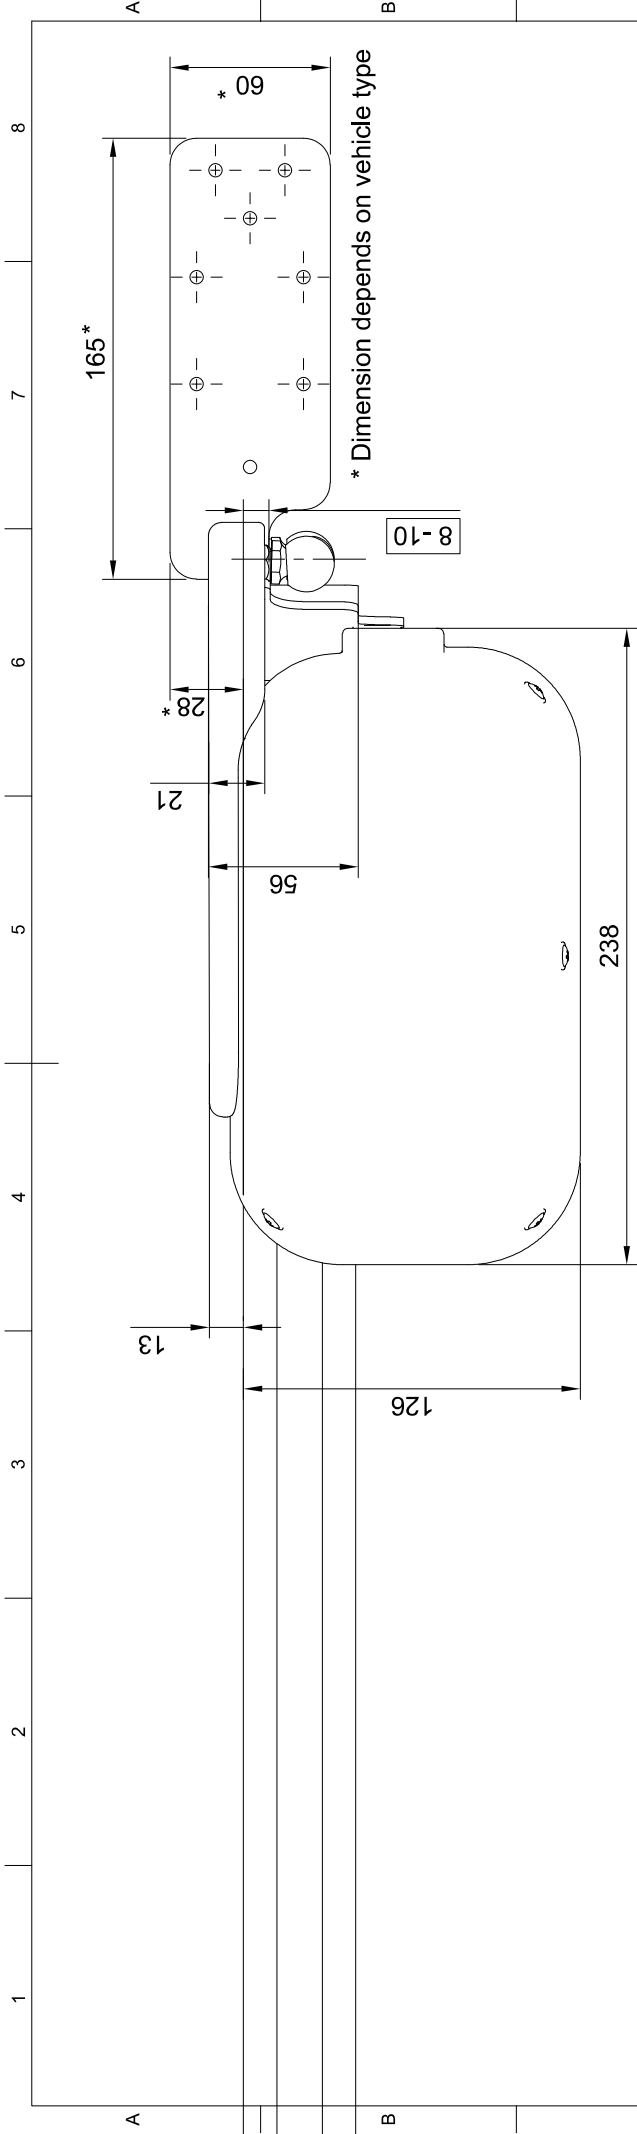
Inner wall surface of the sliding door when closed state

72.5
Depth of the drive in the area of the rear panel

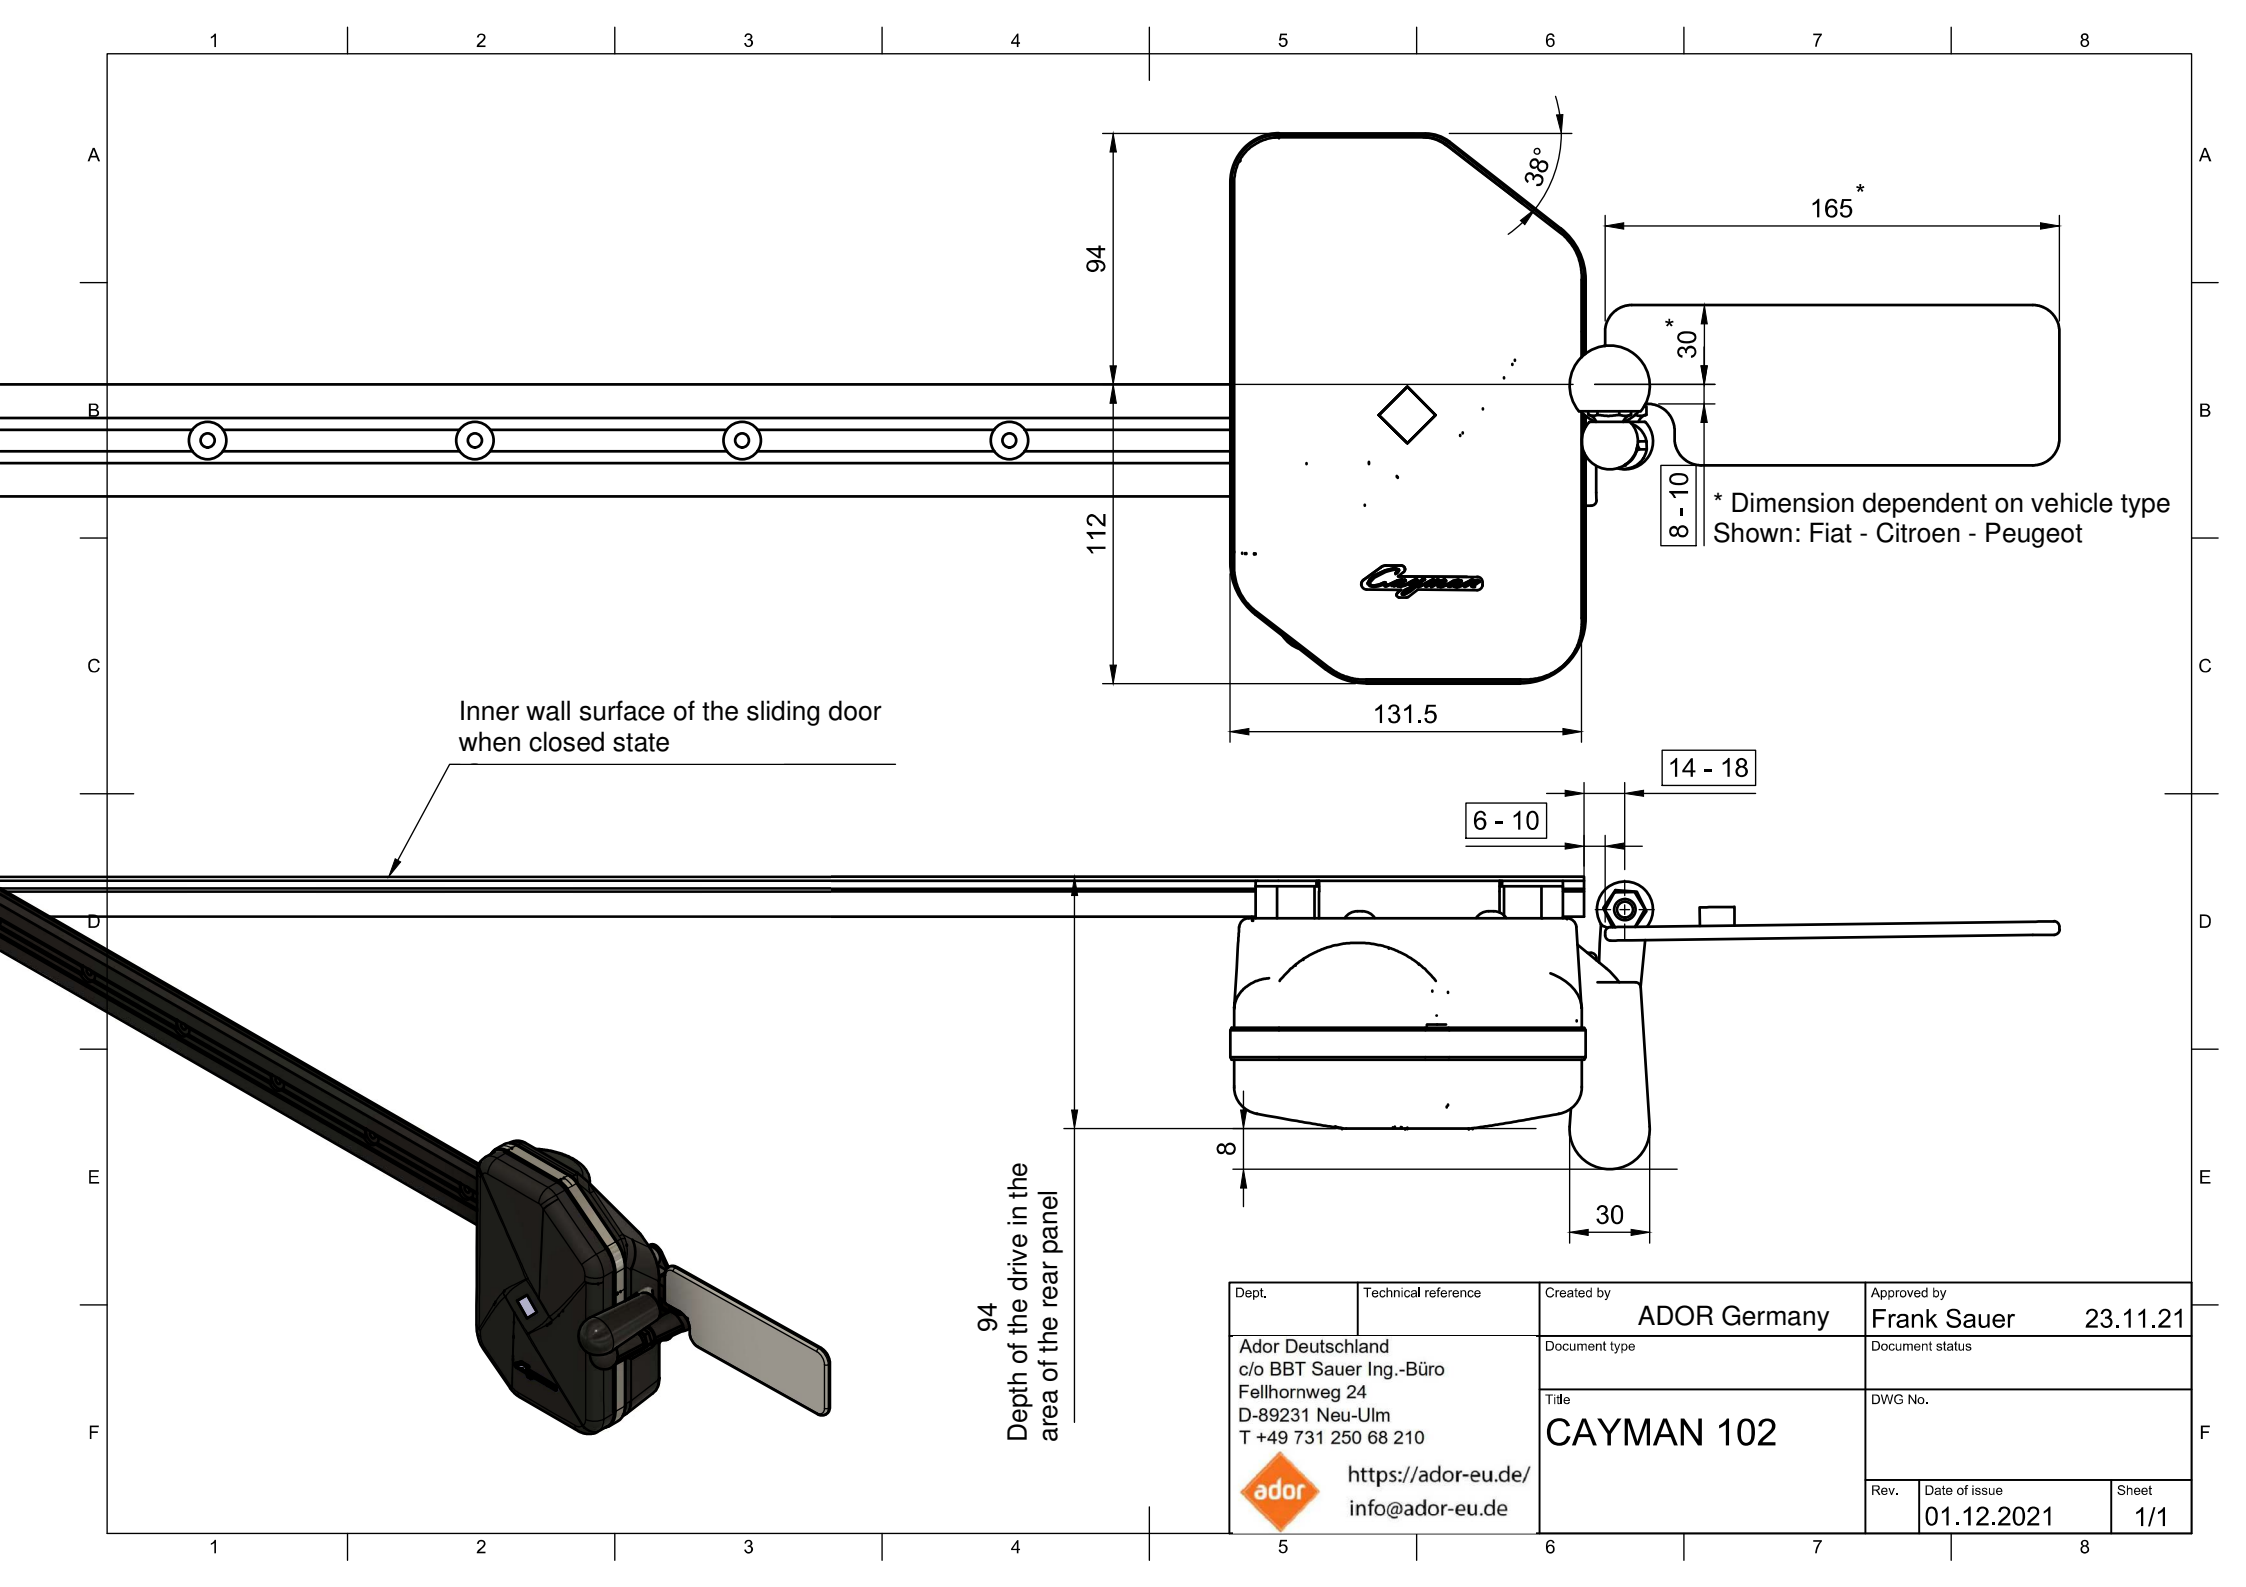
Inner wall surface of the sliding door when closed state

94
Depth of the drive in the area of the rear panel

* Dimension dependent on vehicle type
Shown: Fiat - Citroen - Peugeot
